# ELISSA: A W

## Part III: "Ancl

# ROUGH T IRON BARQUE

## ors Aweigh!"

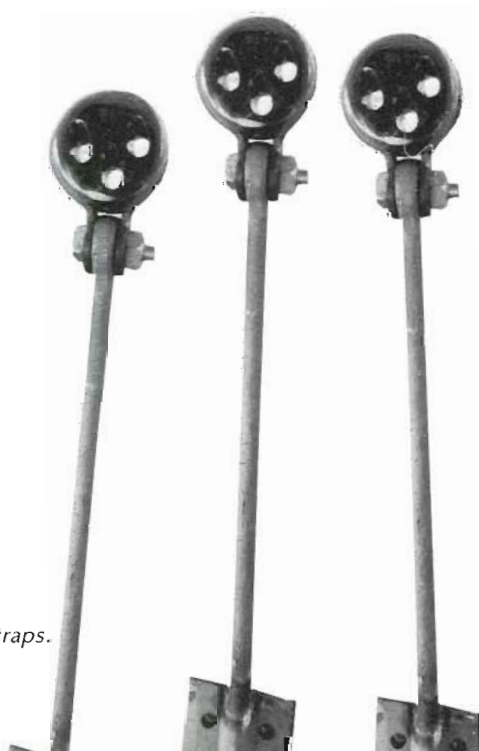
*Dead eyes and dead eye straps.*

Most of the first jobs for the shop were simple, such as forging 3" diam. steel rings using ¾" stock and making U-clips from ½" x 2". Our first major job was forging the dead eye straps. These are steel strapped around a wooden dead eye composed of lignum vitae block (the hardest known wood) which has been turned and drilled. The straps are then bolted to the top ring of the chain plates. This job was the first job that involved major production and the true abilities of the shop were established. Joe Pehoski came down from Salado for a few days and helped get the system for fabrication set up. We made several test runs of the bend to the diameter jig that we had

constructed and found two heats to be optimum for the 20" to 27" straps. Because a 10" to 15" heat was difficult to achieve with the fire pot we were using, Joe suggested a new forge which would produce longer heats and this was later constructed. It was also suggested that we send the straps out to be flame cut to shape before we forged them, which proved to be a great time saver.

The straps varied in length to fit the 4", 6" and 7" diameter dead eyes. In order to bend the straps to the diameter required and have the flared drilled tabs fall in parallel, we first had to bend the tabs to a determined angle. We found that the strap diameters were not constant and circumferences varied  $\pm \frac{1}{2}$ ". To compensate, we altered the point where the bends on the tabs were located. This required that each of the 72 straps be stamped for identification with its corresponding dead eye. Once this process was perfected, the job ran smoothly and was completed to the satisfaction of all concerned, giving the green light for all the work that we could feasibly handle.

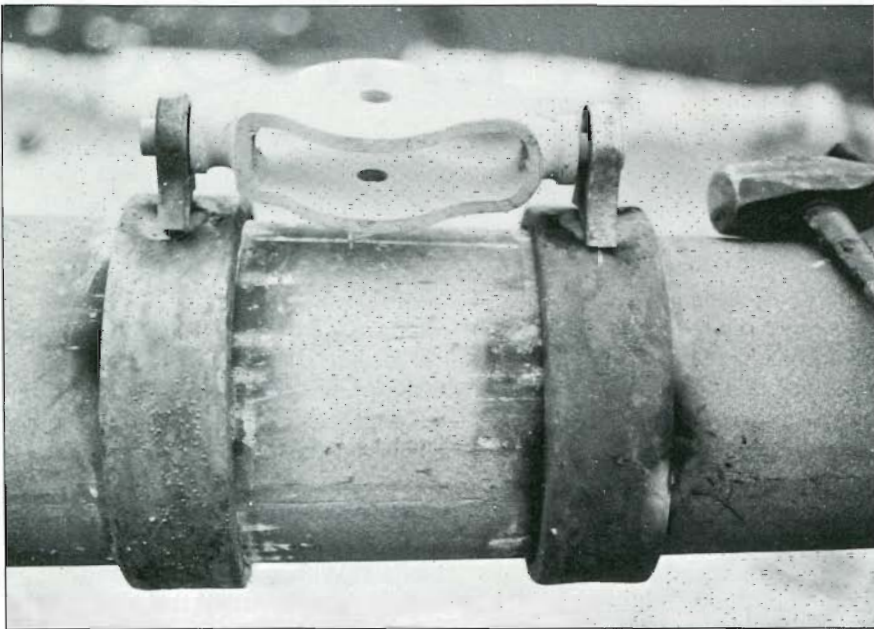
*Outer yard arm bands and pivot block assembly for lower yard arm.*

and planed the spars to the finished diameters required. We then determined the actual location of the band on the spar and measured the diameter at that point. Very often the two ends would vary slightly in diameter. The jig for making the bend would always be made to fit the larger diameter and once the band was forged to the jig it was hammered cold to reduce it to its proper dimension.

Because of the size of the material ( $\frac{5}{8}$ "- $\frac{3}{4}$ "  $\times$  3"-4"), all of these forgings were first forged to a ring; then pre-cut and drilled tabs were arc welded to the rings to create the clamp band. For a properly fitted clamp band the steel should bind on a spot 6"-10" below the desired mark. Then the band is driven onto the mark with some compression ( $\frac{1}{16}$ "- $\frac{1}{8}$ " ) and is clamped with the bolt — if it fits well it compresses the wood  $\frac{1}{8}$ " +, enough to seat. The tabs, when clamped, should line up parallel with a tolerance of  $\frac{1}{16}$ ". Most of these bands then had hardware attachments (rings, etc.) that were full-penetration welded, ground and filed to cover the construction method. This additional welding also caused distortion of the band,

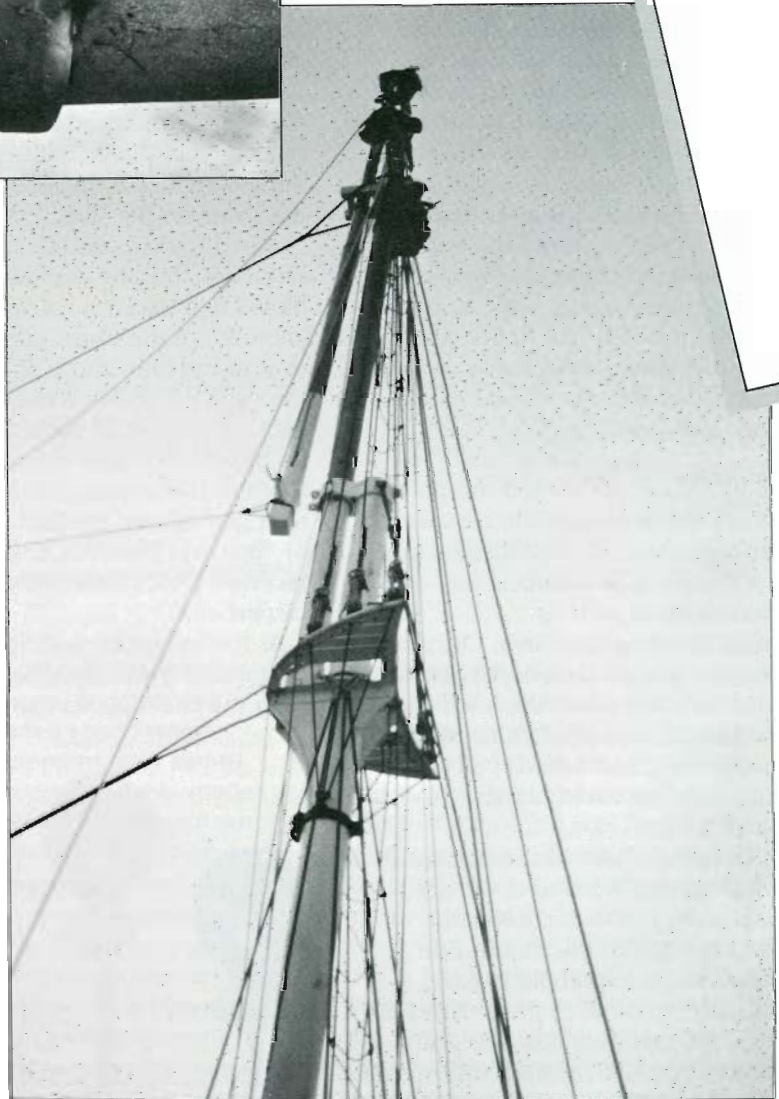
*Stepping of the tagalant royal mast.*
